Cracking discharge lines on Large Cooling only RACs

MODELS EFFECTED: - MAY180, MAY180A, MAY220 & MAY220A

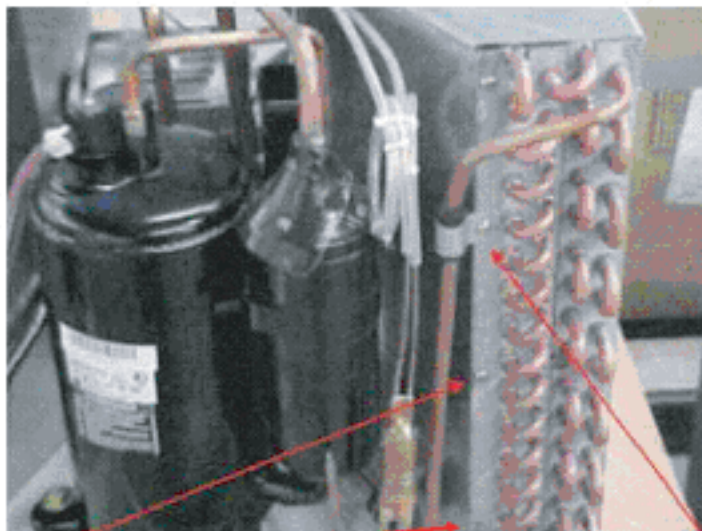
SYMPTOM:- Discharge line split on bottom U Bend.

The units that are failing have the pipe saddled at the middle or bottom of the coil. This saddled position holds the pipe too rigid at the coil end, the compressor vibration is concentrated at the bottom U bend of discharge pipe causing metal fatigue at this point, resulting in the pipe splitting in this position.

Incorrect pipe clamping position

Correct clamping position

If working on one of the units please move the pipe saddle to the top of the condenser coil.
