Oil Separator Capillary Tube Breakages

MODELS AFFECTED:

GC65RCFX, GC55RCFX, GC48RCFX, GC48RCF, GC45RCX

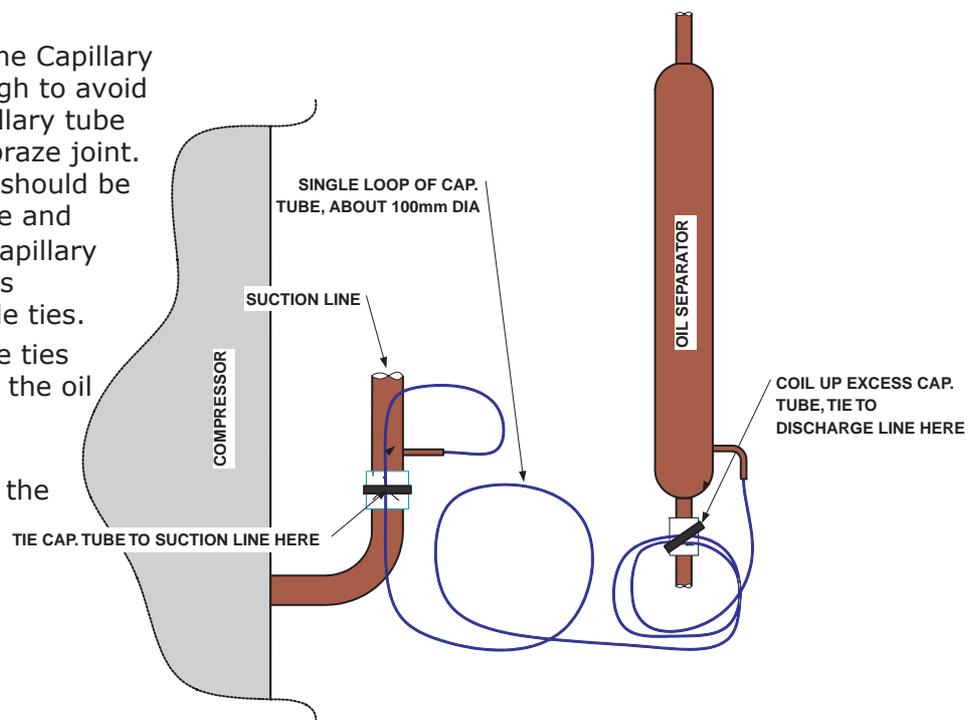
The diagram below shows the suggested layout.

The capillary tube has to absorb the movement between the suction line and the discharge line. One cause of capillary tube fracture is allowing all the flexing of the capillary tube to take place where it has been annealed, where it is brazed into the Oil Separator or into the Suction Line. This can be avoided by ensuring that the required flexing takes place over a reasonable length of capillary tube, and avoiding this flexing from being focussed at the braze joints at either end of the capillary tube.

One way of doing this is to tie the capillary tube to the suction line just before the tube is brazed into the suction line, then form a single, large loop in the capillary tube. The rest of the capillary tube can be coiled, and that coil tied securely to the discharge line where it enters the oil separator.

The ties at either end of the Capillary tube should be tight enough to avoid the movement of the capillary tube being transmitted to the braze joint. A piece of tube insulation should be put around the suction line and discharge line under the capillary tube and the ties. The ties should be large nylon cable ties.

When replacing an Oil Separator/Capillary Tube, the capillary tube should be annealed over the length of the capillary tube that will be between the two ties.

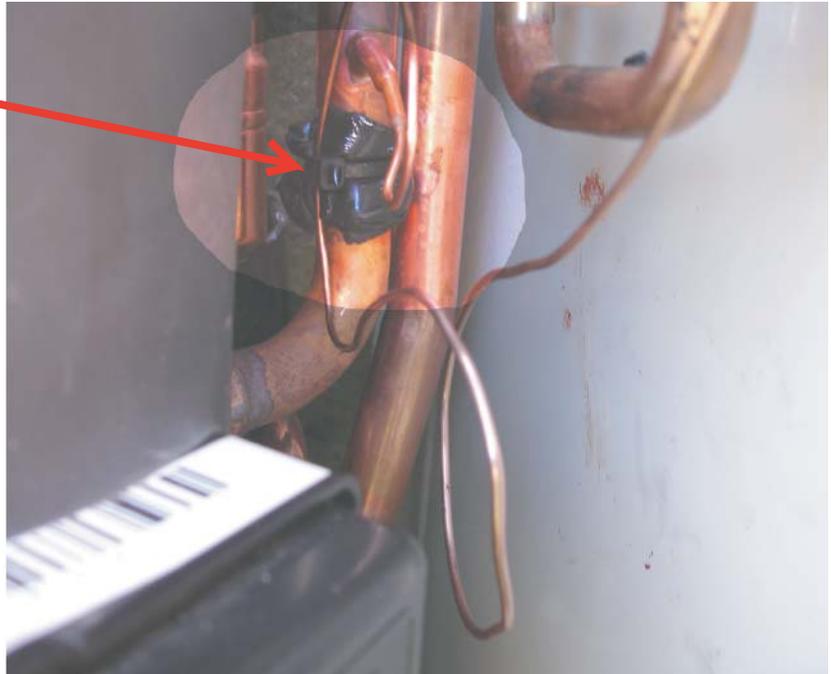
Tie at Suction Line

Two photo's over show the ties at the suction tube and at the oil separator respectively.
